NASA  
Engineering Directorate  
Materials Science Division  
Kennedy Space Center, Florida

KSC-MSL-2010-0344

SUBJECT: Post STS-133 Evaluation of Main Flame Deflector Witness Materials

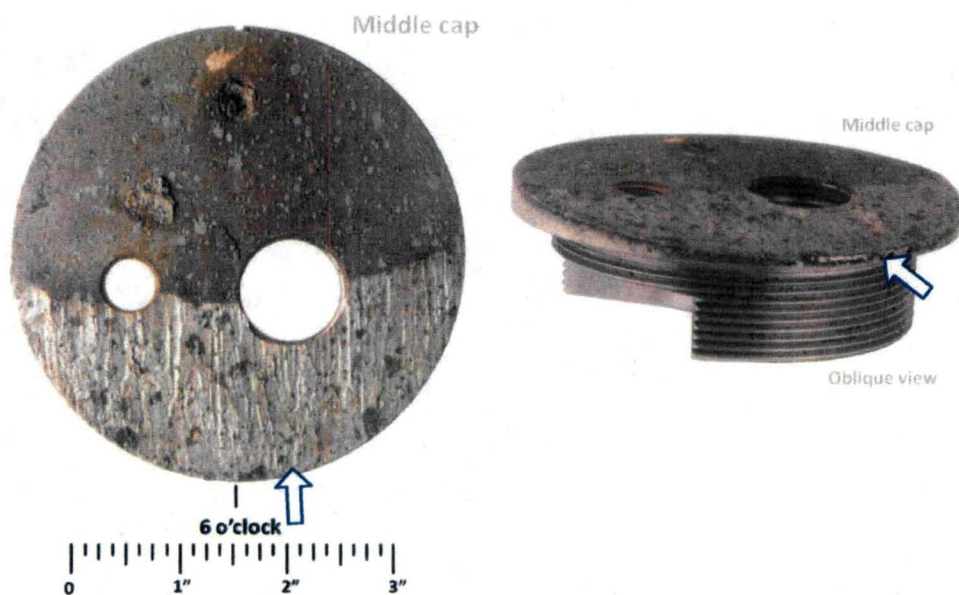
Figure 4. Middle 304 stainless steel cap, as received. Arrows indicate location of erosion. The 6 o'clock position on this sample was chosen in the laboratory since the customer had not designated a reference position for dimensional measurements. Scale is three inches.

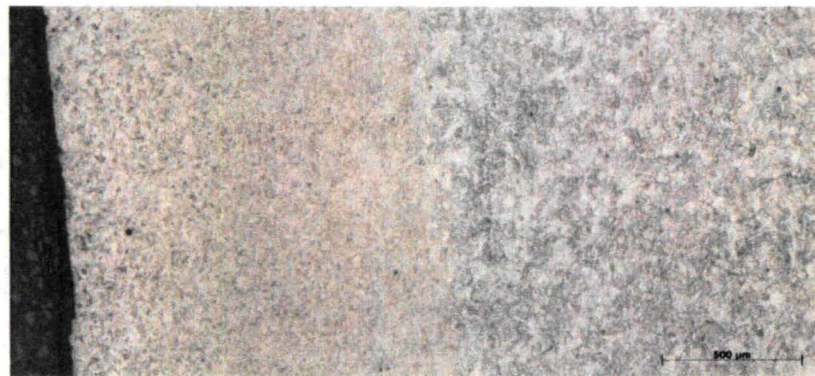
Figure 13. Micrograph of the surface (left) of the top sample HY-80 witness rod showing the untempered martensite in the heat affected zone and tempered martensite in the parent metal. Etchant: diluted nital. Original magnification: 100X
